RAILROAD ACCIDENT INVESTIGATION

Report No 3835

RUSHVILLE, IND

JANUARY 12, 1959

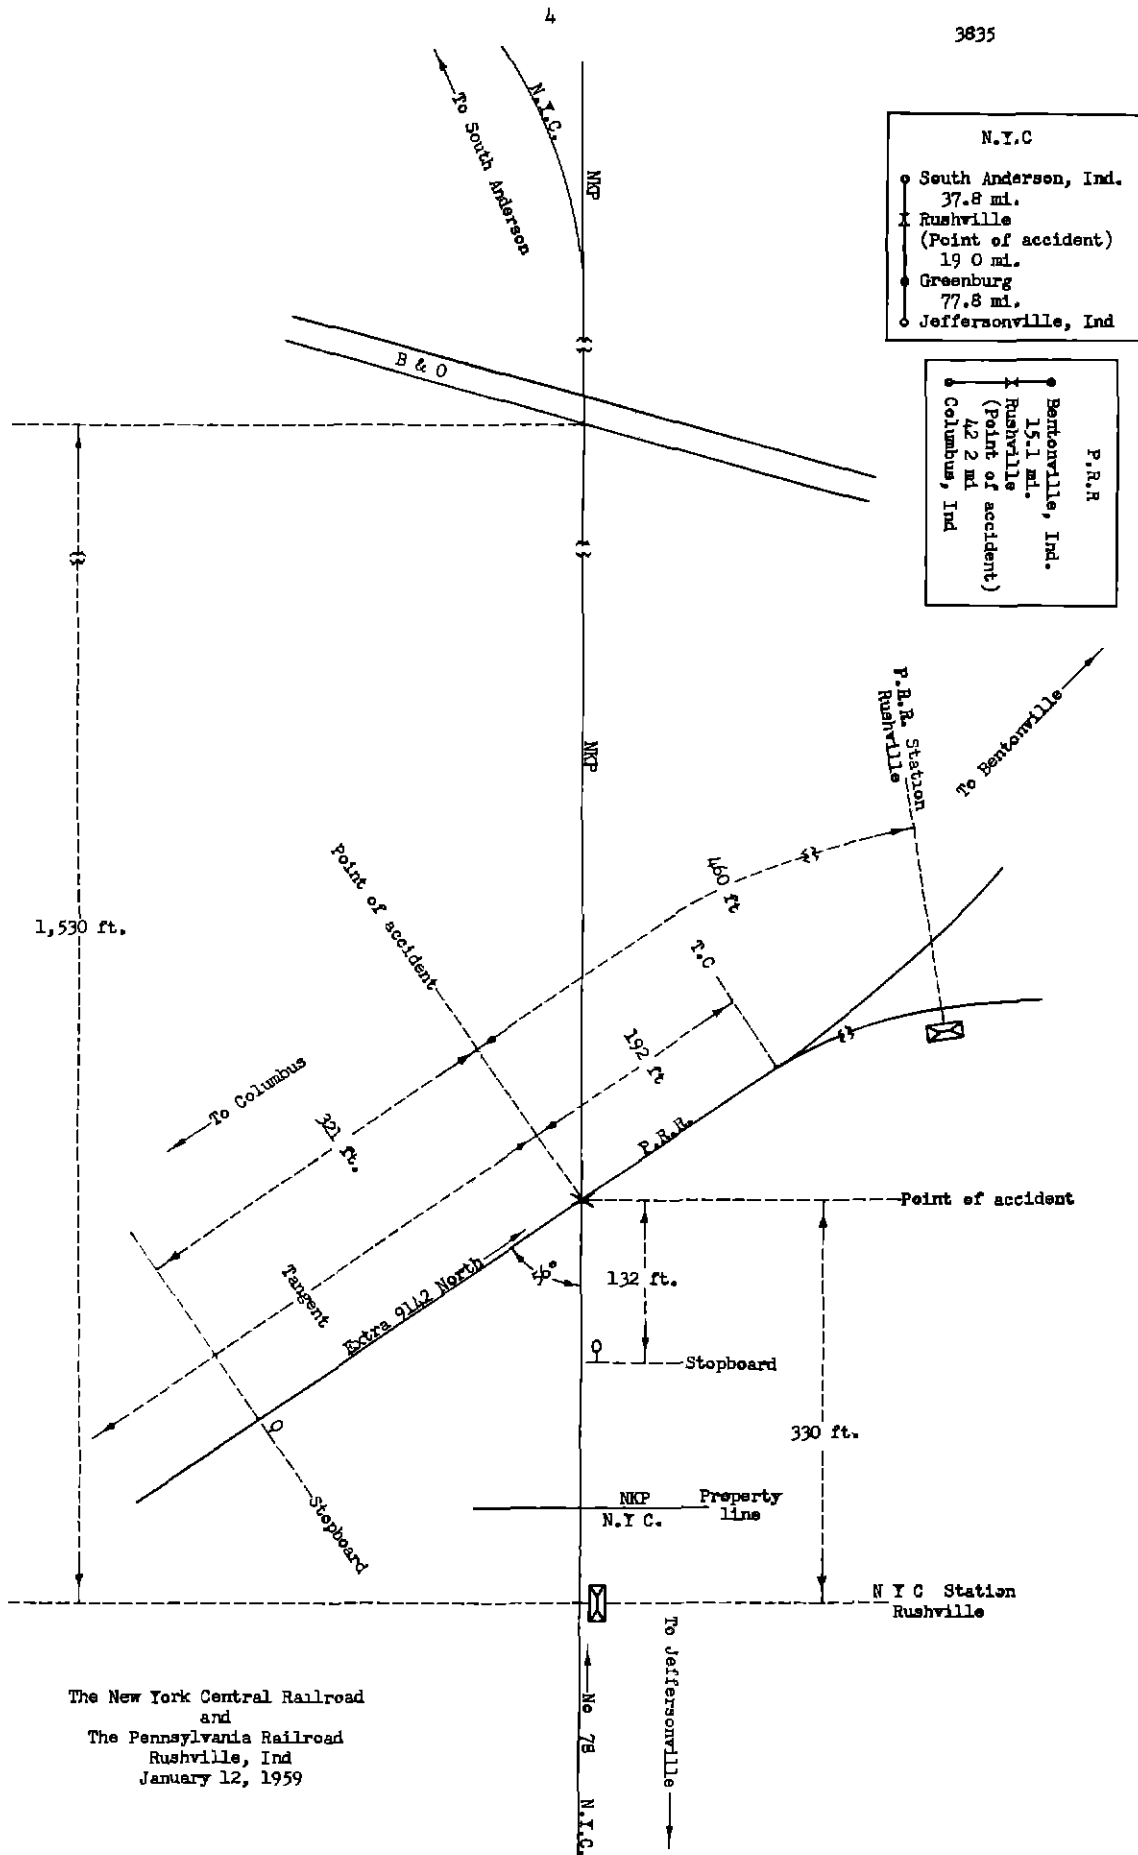
The New York Central Railroad
and
The Pennsylvania Railroad
Rushville, Ind
January 12, 1959

The 4th, 5th, and 6th cars of PRR Extra 9142 North were derailed and stopped on or near the PRR and NKP track structures. The 4th car was destroyed, and the 5th car was considerably damaged. NYC No 78 stopped with the front end 52 feet north of the crossing. The front truck of the 1st diesel-electric unit was derailed, and this unit was considerably damaged.
